MARINE INVESTIGATION REPORT

M99F0038

MAN OVERBOARD/DEATH

THE RAIL BARGE "JUNEAU", ACCOMPANIED BY THE TUGS
"SEASPAN PACER" AND
"ESCORT EAGLE"

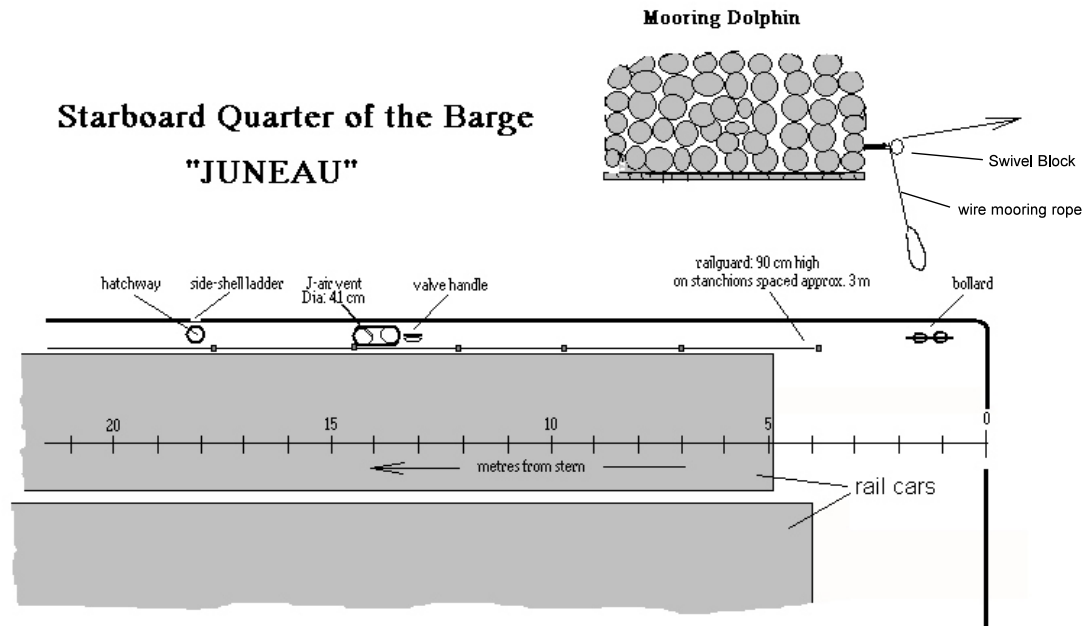
Figure 2

The "JUNEAU" has a wire rope safety line running along each side, supported by angle-iron stanchions welded to the deck. Positioned about 60 cm inboard from the edge of the deck, the line is about 90 cm high and ends about 4 m from the stern (see Figure 2).

The walkway safety lines on the "JUNEAU" follow the same design and location (60 cm inboard of the edge) as those on the chip barges. For protection against falling overboard, a person must hold on to the line continuously while using the walkway. On the chip barges, the safety lines were attached—inboard of the edge of the deck—to pre-existing deck box stiffeners. The "JUNEAU" does not have such stiffeners, and neither the stanchions nor the lines were attached to any existing fixtures on the barge. When these safety lines were (fairly recently) installed, there was no pre-existing structure influencing their location, and they could have been

It was logical to place the bollards at the edge of the barge. While the manholes, cleats, handholds and other low-profile protrusions are obstacles, a trained seaman could easily pass by them. However, the 41 cm diameter vents in the 60 cm wide walkway were not placed with full regard to the safety of personnel, though handholds had been installed on the top of each vent. A person passing by the vent uses both hands to hold onto the bars on top of the vent. While passing a vent, a person’s centre of gravity briefly passes over the side of the barge; this occurs while the only available foothold is the 19 cm wide, uneven surface between the body of the vent and the edge of the deck.

It is possible for a physically fit person, with only one hand free, to pass the vent while grasping the bars with only one hand. However, such a manoeuvre is unsafe—especially when the deck is wet and footing may be easily lost.

- fuel and water vents were capped at deck level;
- containment berms around these vents were removed;
- additional handhold was installed on the top of the ballast vent; and
- vent lid dogs were removed.

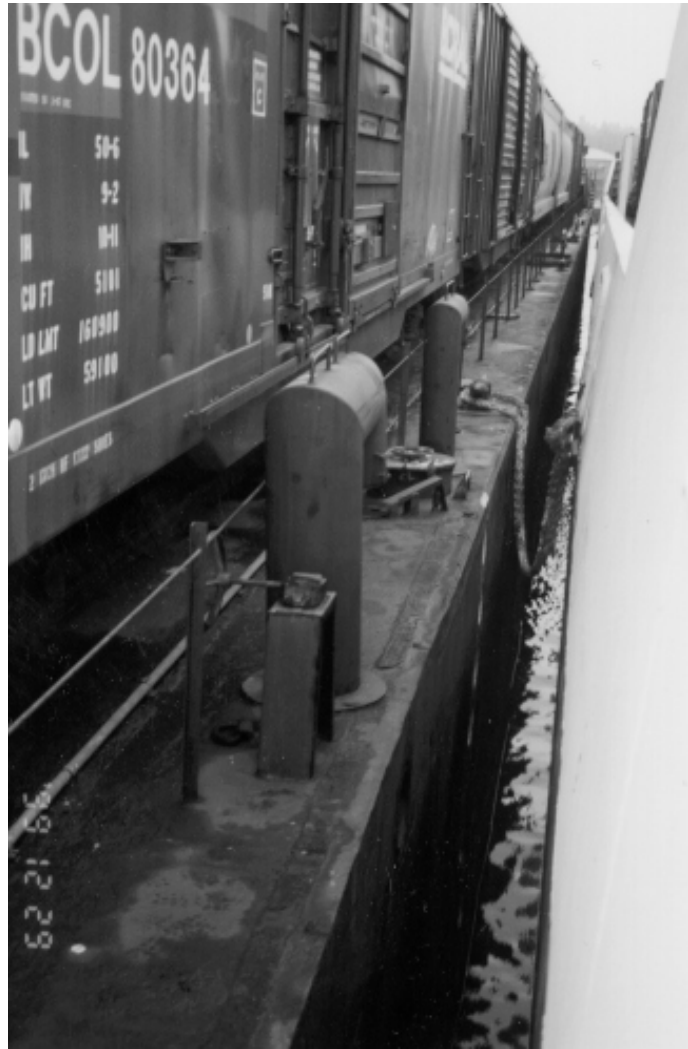
Figure 3 - The walkway with the rail tracks occupied

When the railcars are loaded and stowed on all six tracks, the entire width of the deck between the safety lines is occupied. The 60 cm space outside of either safety line is thence used as a walkway between the bow and the stern. Along the walkway are several items attached to the deck, including cleats, hatchways, eye pads and vent pipes.

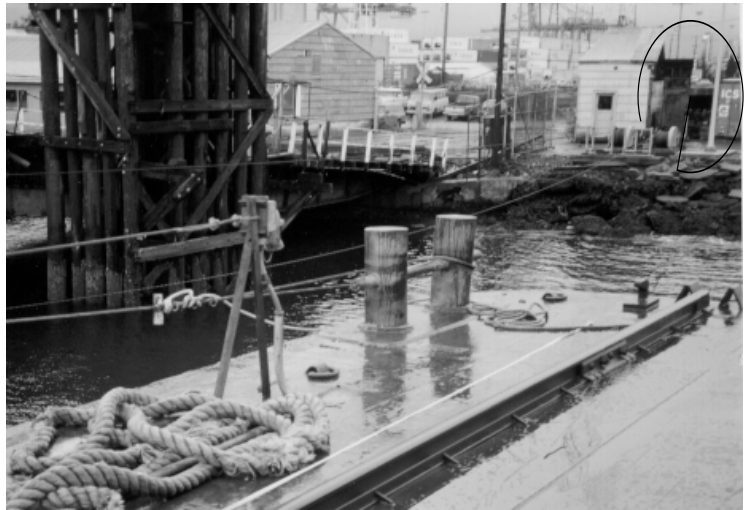
The weather was reported as foggy with light wind and calm water surface. The accident occurred at dawn, and it was still dark. There were no permanent deck lights on the "JUNEAU" and no deck lighting was provided; neither of the tugs was in a position to use its spot lights to light the starboard quarter of the barge. Some lighting was coming from the rail ramp but, with rail cars on the deck, the starboard quarter of the barge was in shadow.

Figure 5 - Starboard quarter of the barge.
Mooring winch and lamp post ashore are circled.

The lack of dedicated lighting made sighting the deck fixtures difficult and, consequently, would have made passage across the deck—over and around the deck fixtures—more difficult to execute safely.
